UPPER CLEAR CREEK MITIGATION BANK MITIGATION BANKING INSTRUMENT

PIERCE COUNTY, WASHINGTON

MITIGATION BANKING INSTRUMENT

Upper Clear Creek Mitigation Bank

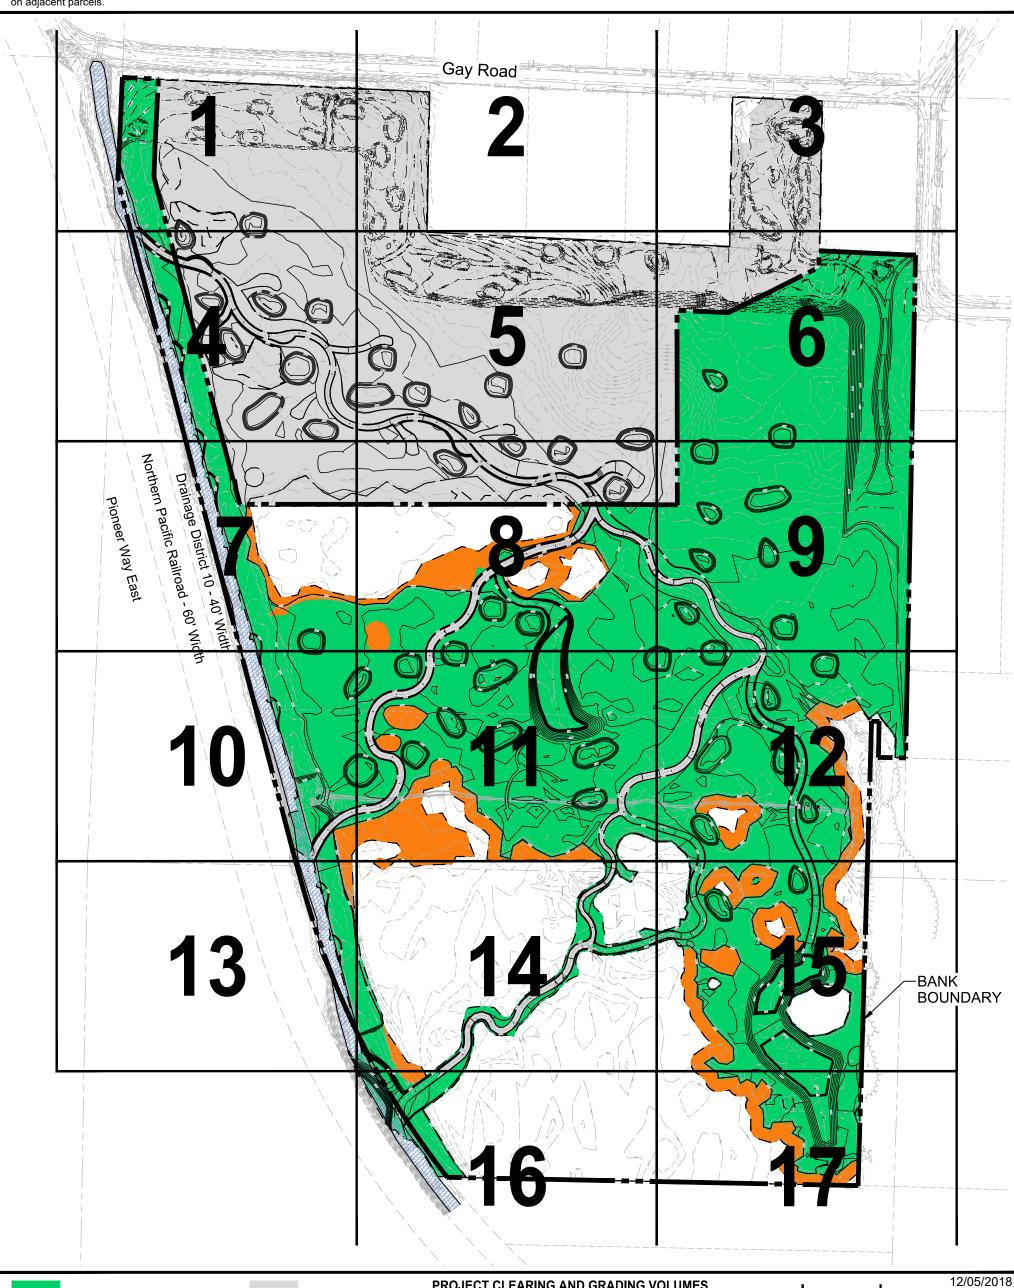
Figure B4: Clearing and Grading Overview

PROJECT CLEARING AND GRADING VOLUMES

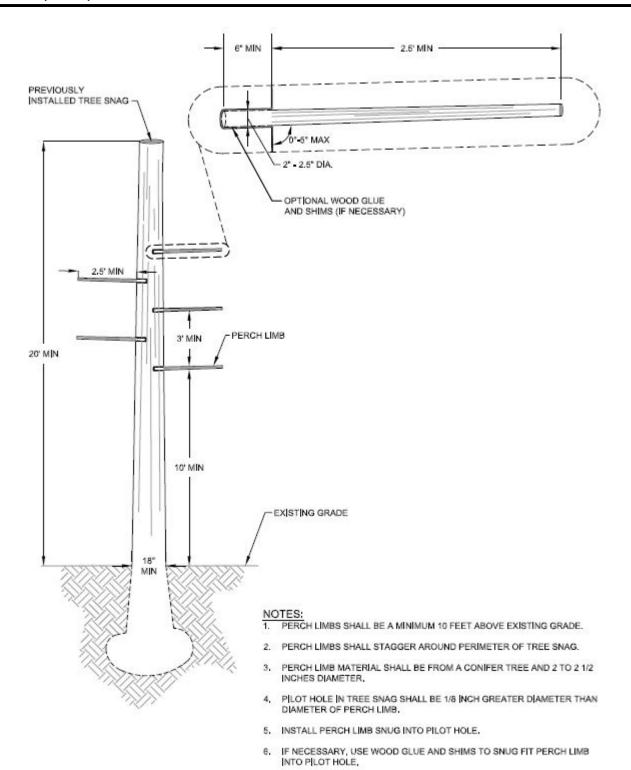
TREE SNAG PERCH LIMB INSTALLATION DETAIL

7. EACH TREE SNAG SHALL HAVE A MINIMUM OF 5 PERCH LIMBS.
